**FINAL  
REMOVAL ACTION COMPLETION REPORT  
November 30, 2007**

**DCN: ECSD-5713-0072-0004**

**METAL DEBRIS REEF AND METAL SLAG AREA EXCAVATION SITES  
PARCELS E AND E-2, HUNTERS POINT SHIPYARD  
SAN FRANCISCO, CALIFORNIA**

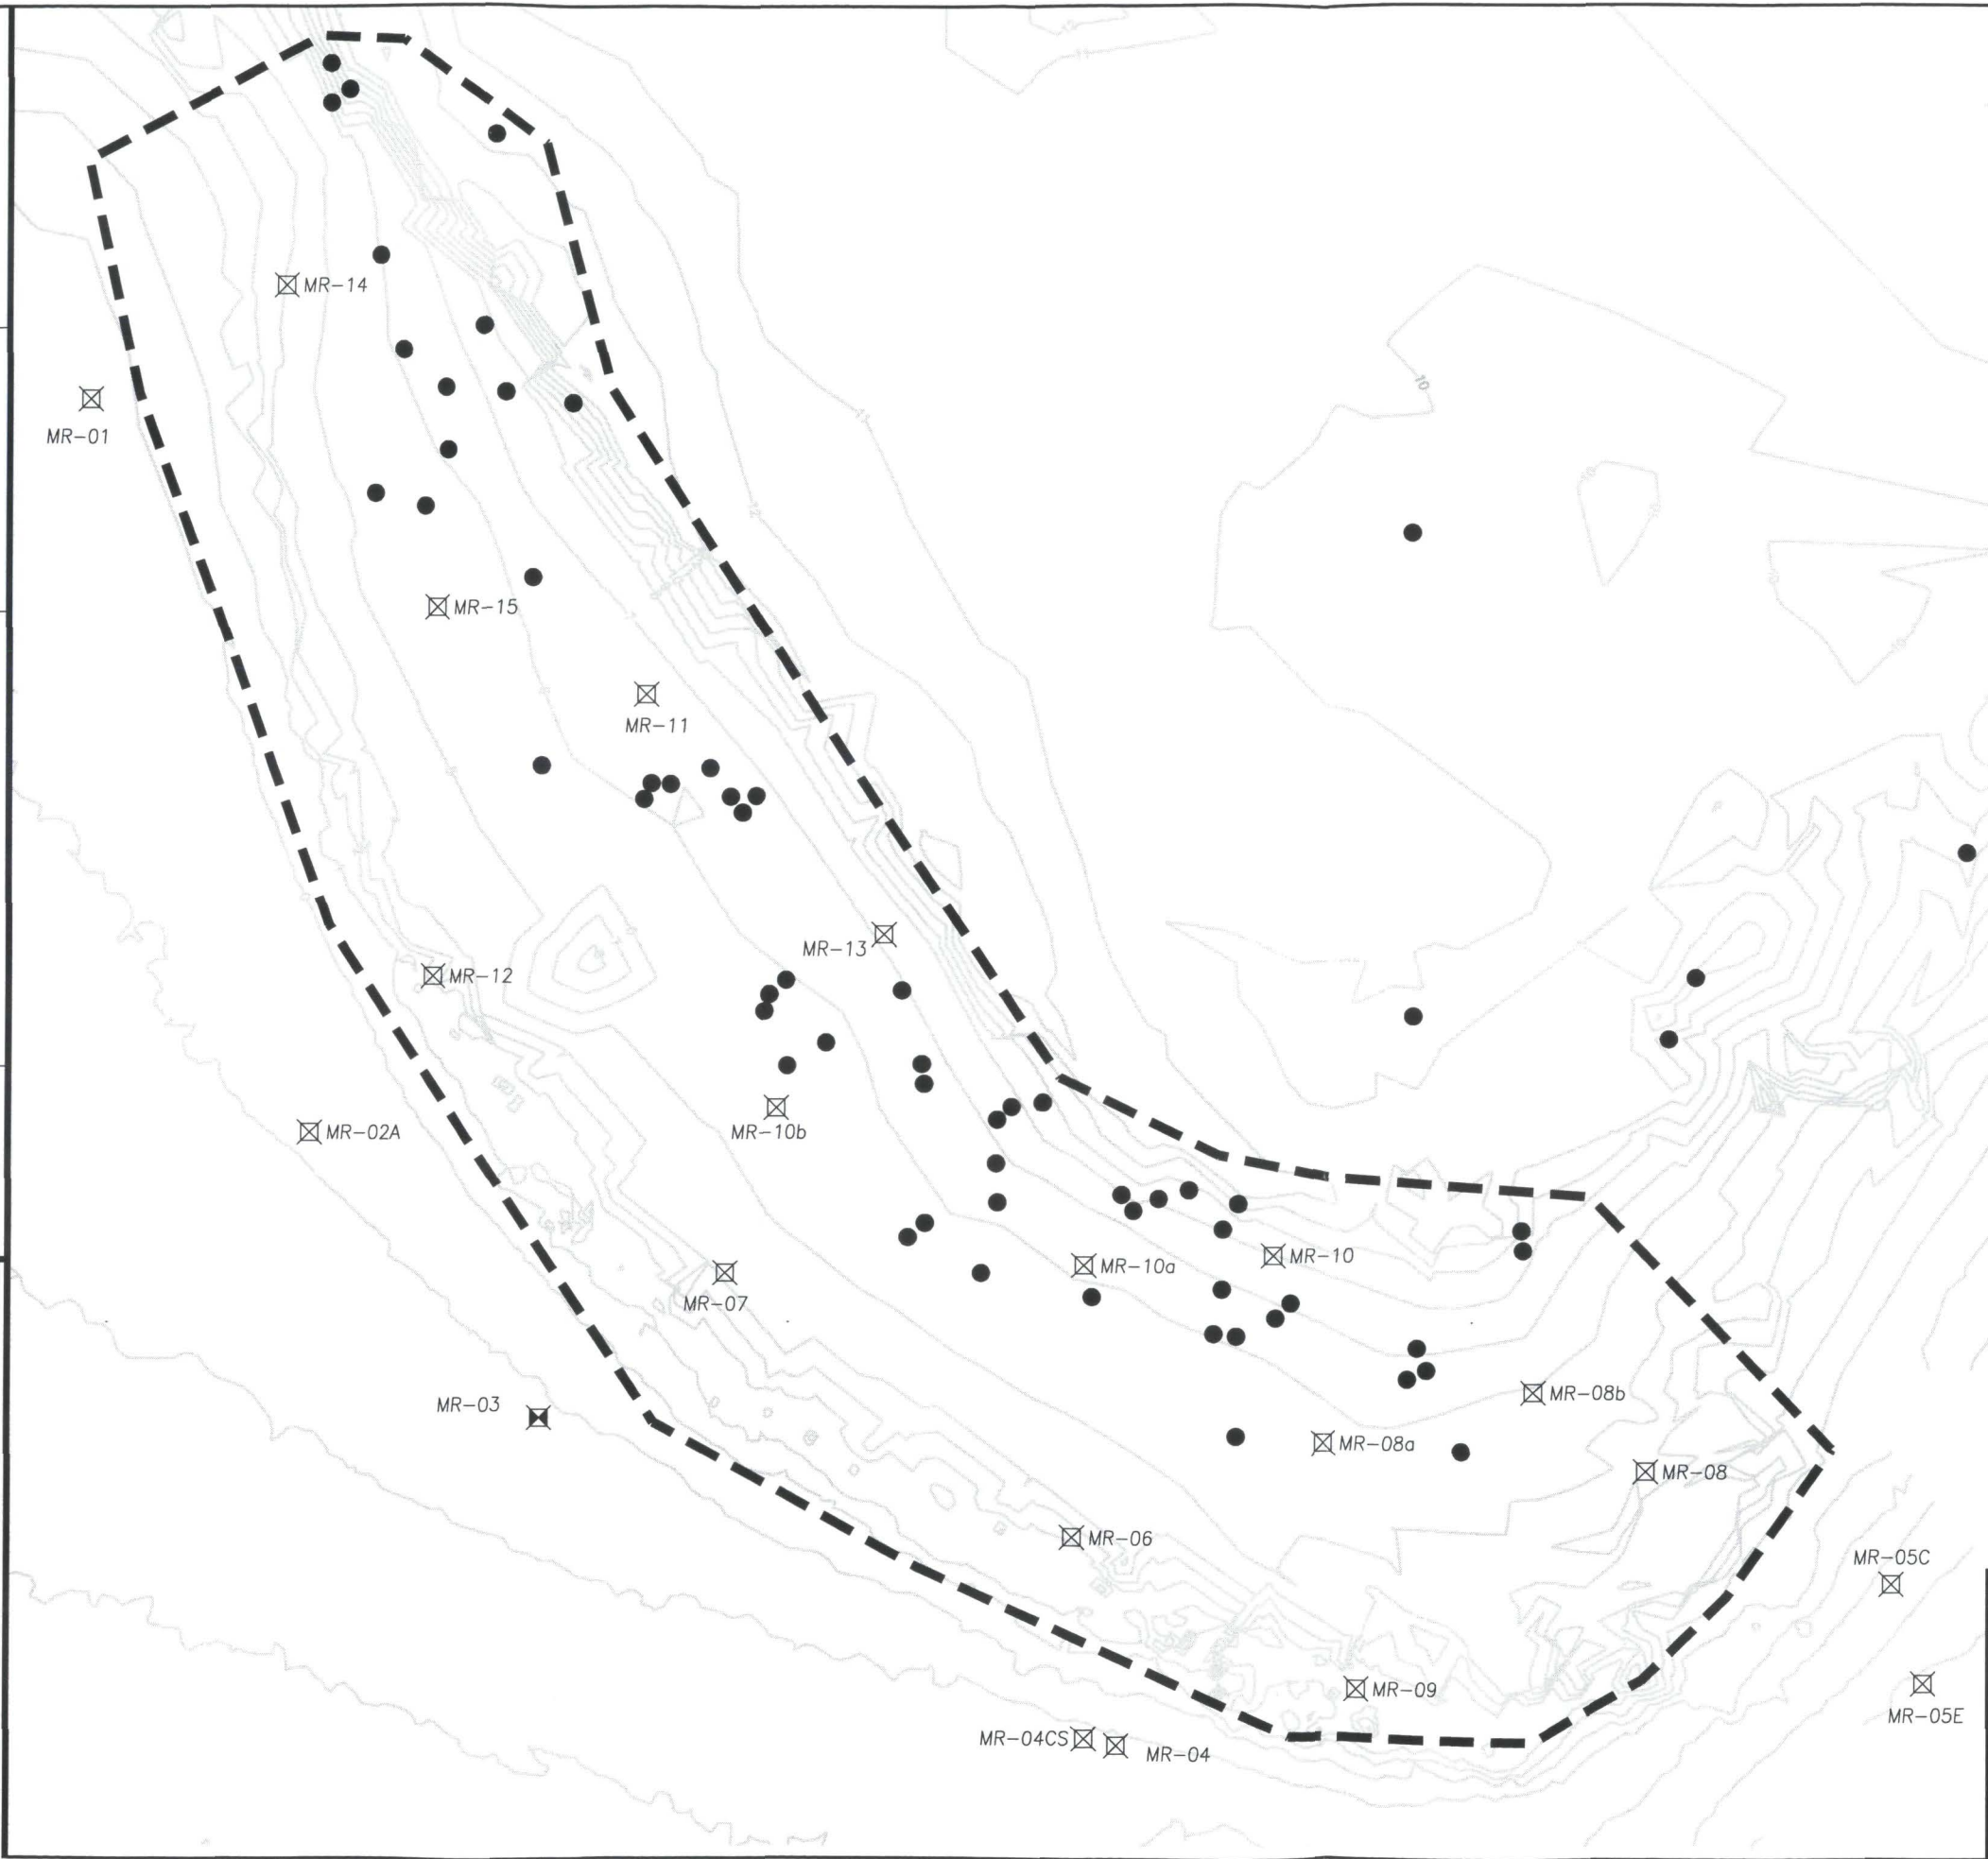
<p>FIGURE 2-3 METAL SLAG AREA 2004 CHEMICAL CHARACTERIZATION SAMPLE LOCATIONS</p>	
<p>HUNTERS POINT SHIPYARD-SAN FRANCISCO, CA</p>	
	<p><b>TETRA TECH EC, INC.</b></p>

The Phase I investigation revealed one elevated reading in the Open Burn Disposal Area and five elevated readings by Berth 36 (see Figure 2-3) at MDR. The Phase I investigation revealed five elevated readings at MSA (see Figure 2-4). The results of this investigation indicated that radium-containing devices may be present in MDR and MSA. Other sources of radiation encountered may be in the form of sandblast grit. HPS used sandblast grit to decontaminate ships involved in atomic weapons testing and may have disposed of some of the grit at MDR and MSA [Naval Sea Systems Command (NAVSEA), 2004].

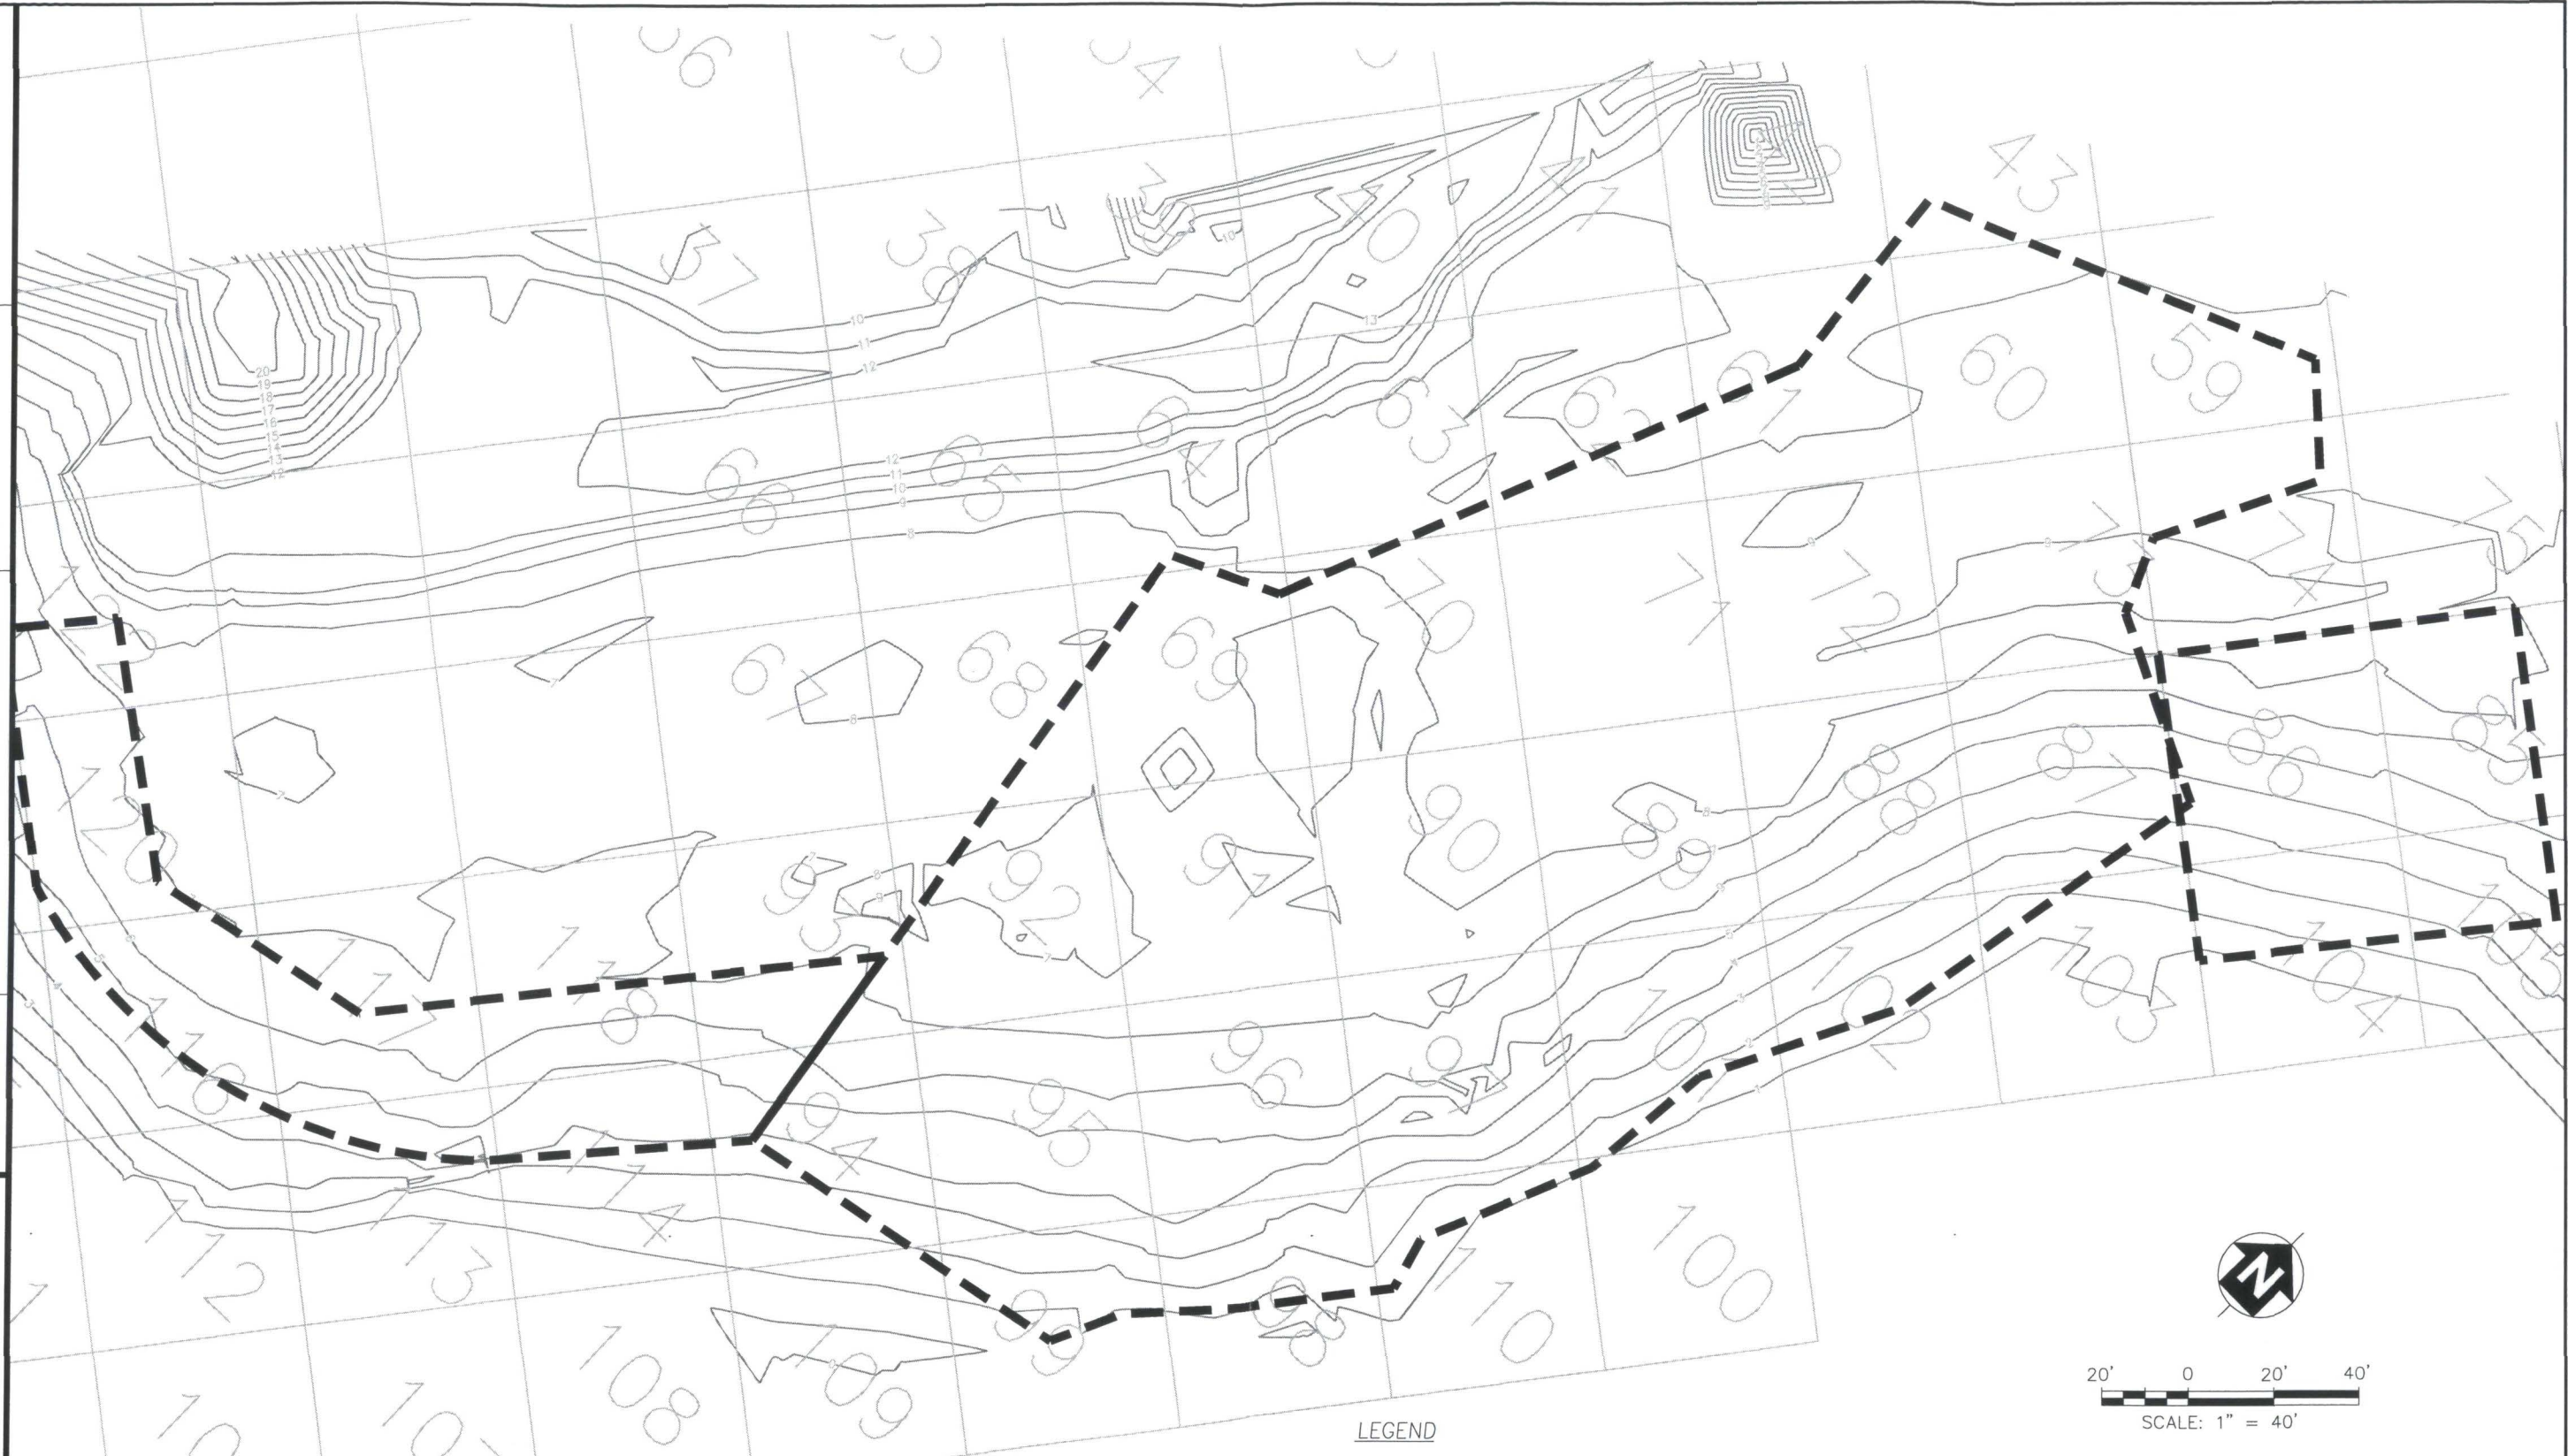
FIGURE 5-2 METAL SLAG AREA PRE-CONSTRUCTION TOPOGRAPHIC CONTOUR MAP	
HUNTERS POINT SHIPYARD-SAN FRANCISCO, CA

To allow comparison with the pre-excavation topographic survey (Figures 5-1 and 5-2), MDR/MSA were resurveyed following backfill and final grading (Figures 5-3, and 5-4). The figures document the pre- and post-excavation surface elevations. The surveys recorded the topographic conditions of the land area within the final MDR/MSA excavation boundary in sufficient detail to generate a topographic map with 1-foot elevation contour intervals.
